RECREATIONAL BOAT SAFETY COLLISION RESEARCH-PHASE II  
VOLUME II - COLLISION ACCIDENT INVESTIGATIONS - 1975

Wyle Laboratories  
Huntsville, AL

Jul 76

REPORT NO. CG-D-129-76

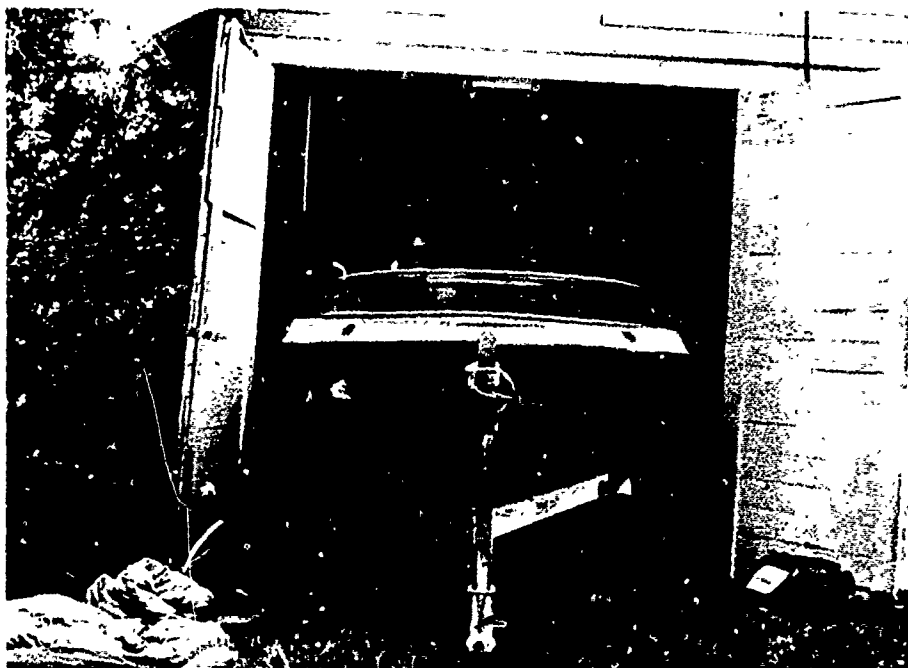
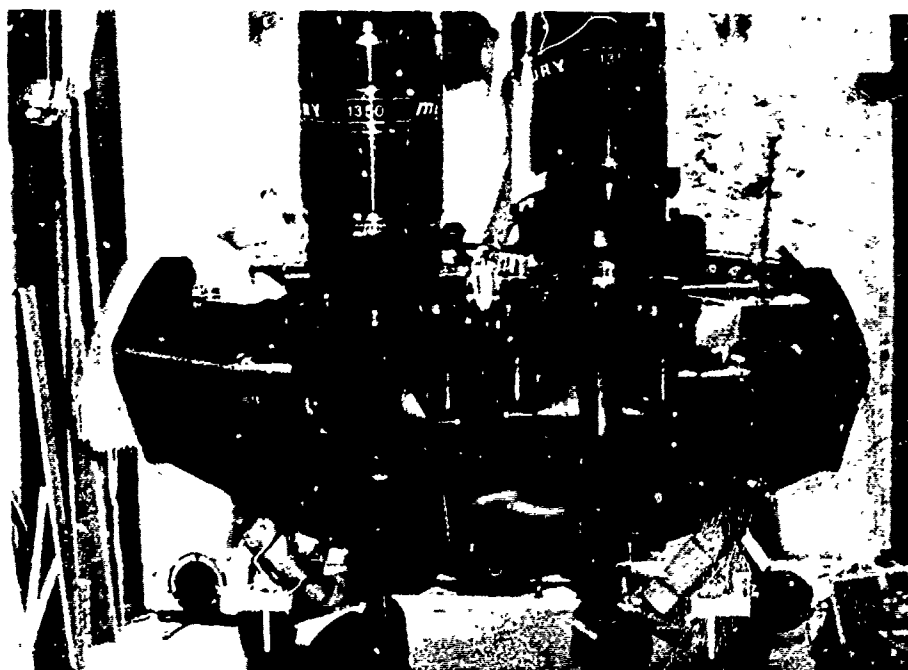
Examination of the boat showed minor damage on the port bow about 6' aft (see Figure 3). Of considerable interest was the fact that this small runabout was equipped with twin 135 hp Mercury outboards with power trim. The transom had been raised to accommodate the motors. They were each equipped with two bladed bronze cupped props. Twin single lever Mercury controls were used. Otherwise, the boat appeared well kept and in good working order. The only exception was that the starboard running light was inoperable (blown lamp). All steering and engines controls operated properly. However, the controls for the power trims were mounted on a wooden panel, but were not connected to any boat structure. They were simply lying on the deck by the operator's right foot. Apparently, the installation was never completed. The 18 gallon tank was about 1/4 full. The boat was kept stored in a garage at the owner's father's home (see photographs 5-8).

Photograph 5 Sixteen Ft Sidewinder Runabout

Photograph 6. Sixteen Ft Sidewinder Runabout

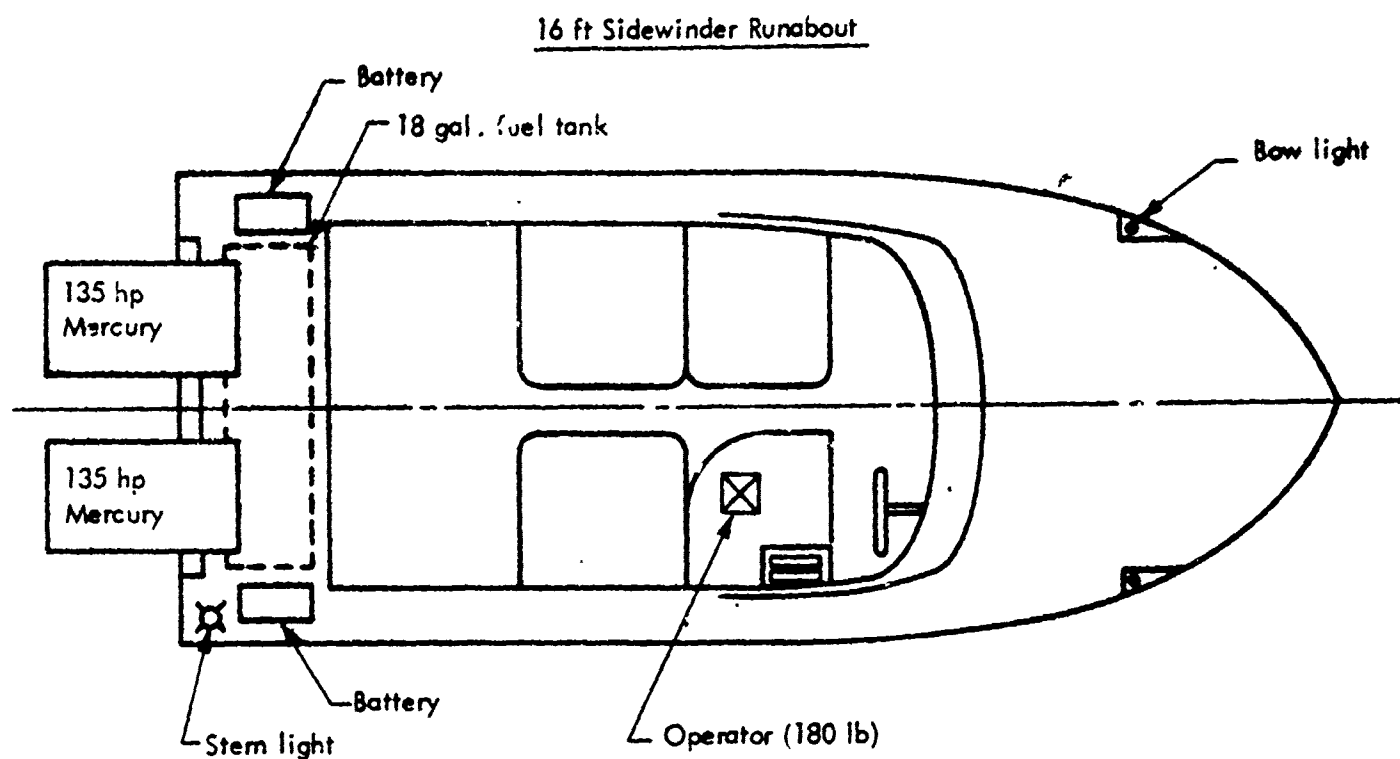
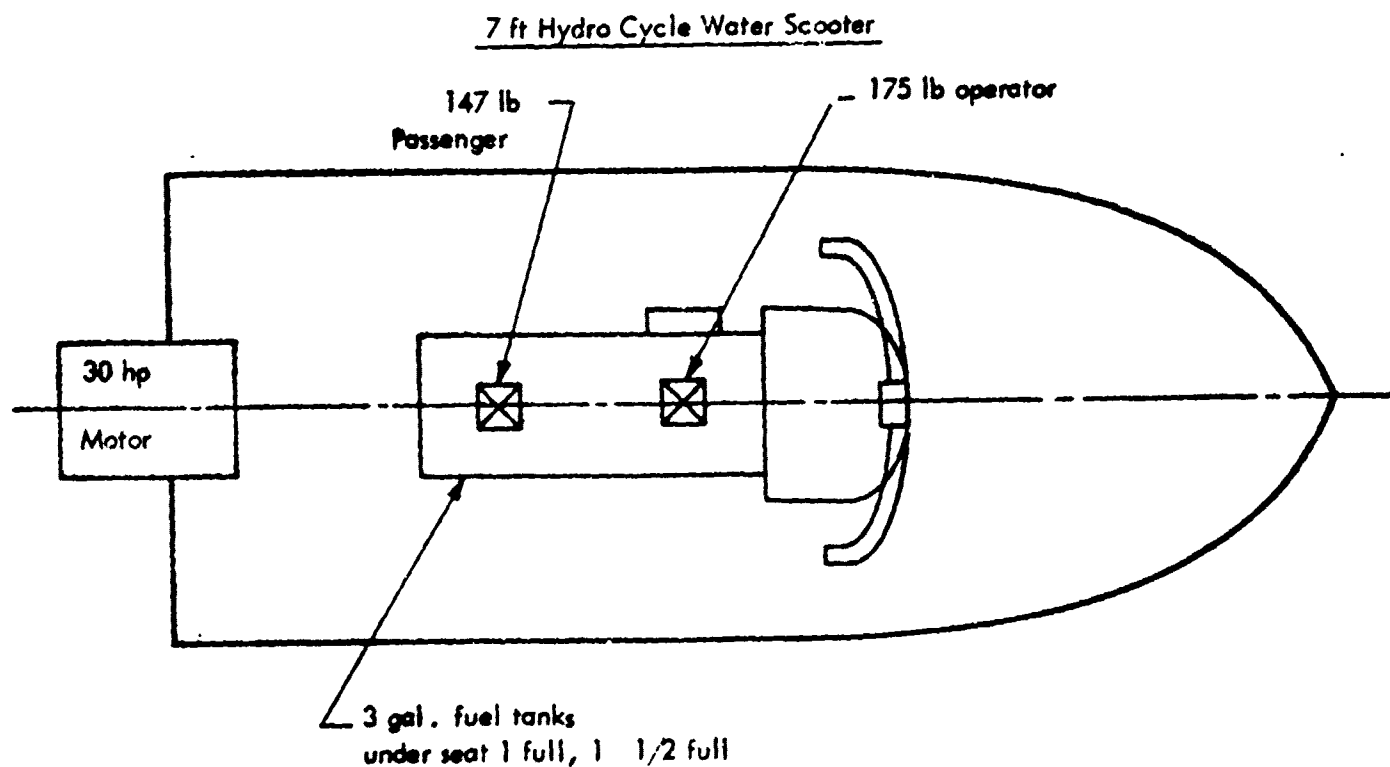
Figure 2. Boat Load Distribution At Time Of Accident

Gear aboard was as shown in Figure 2 and the weather as noted in Section 2.0

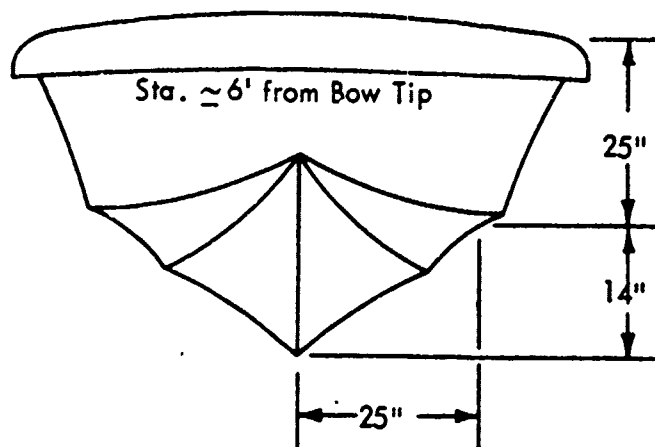
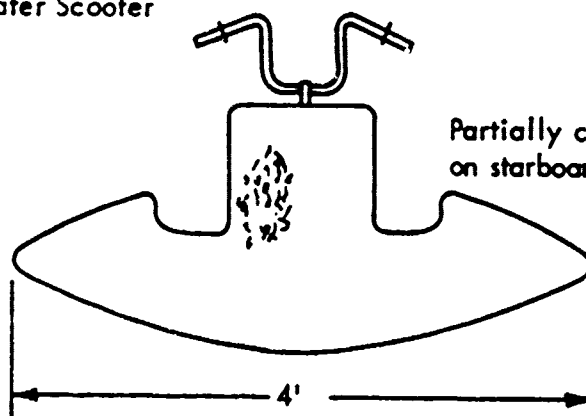
The boat hull photographs, and the testimony of the investigating officer and the bystander all indicate that damage was found on the starboard side of the water scooter as shown in the boat damage sketch (Figure 3).

The impact velocity was probably quite high (20 - 25 mph) as seen from the damage to the water scooter.

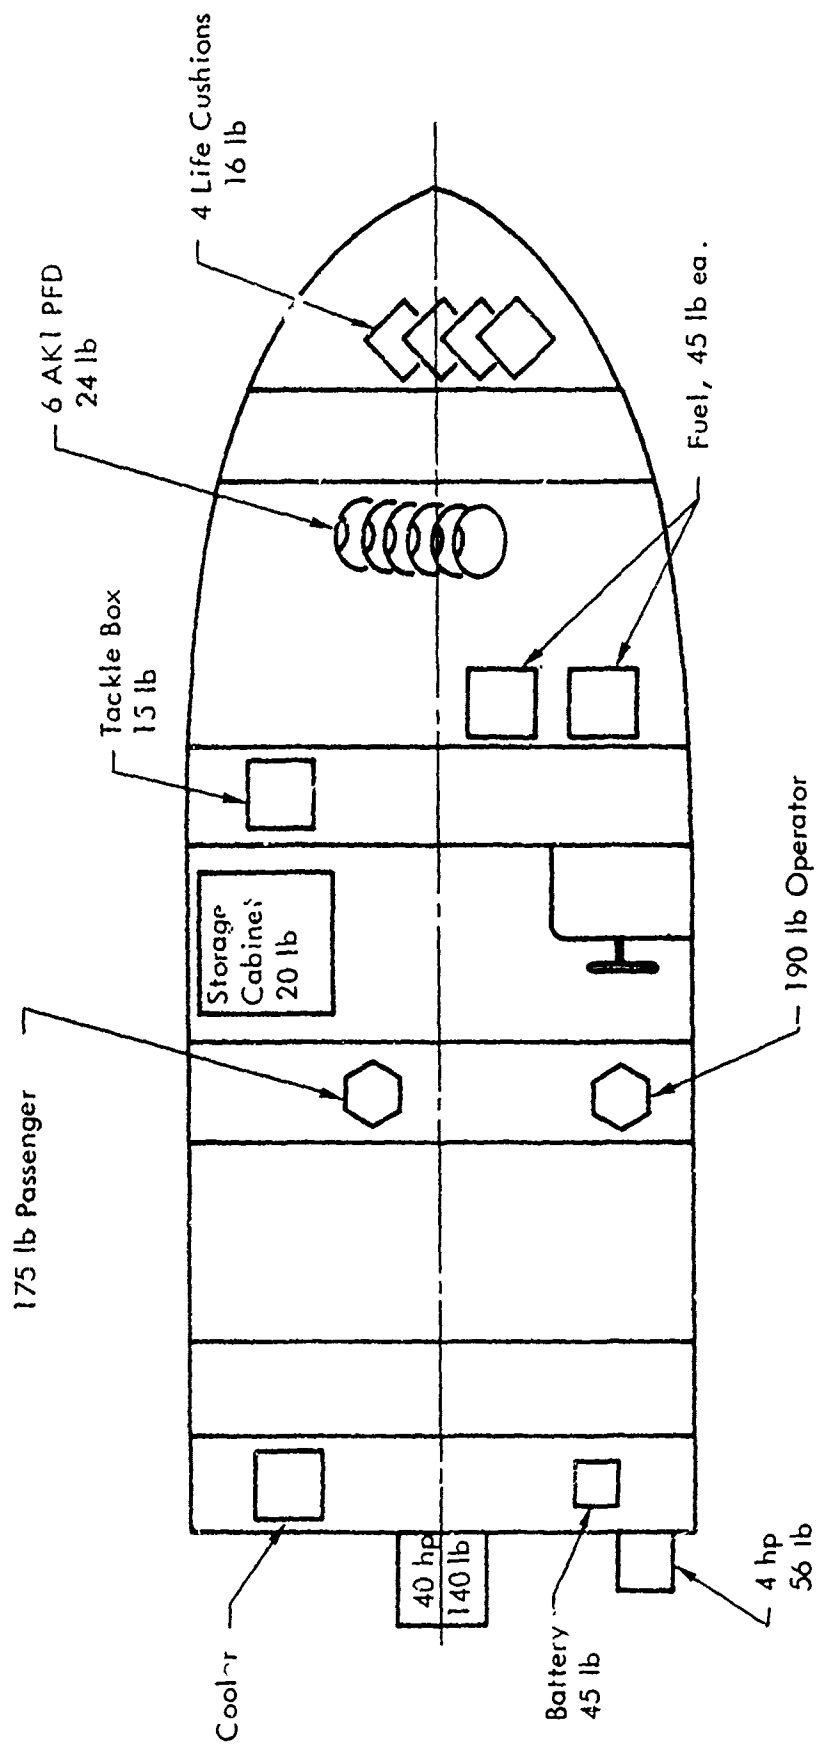
Figure 1. Load Distribution At Time Of Accident

The boat impacted the obstruction bow on and there was evidence that the occupants were thrown forward parallel with the longitudinal axis of the boat. Therefore, it is assumed that the boat remained transversely level during and after the impact.

The operator stated that he may have tried to turn the boat to starboard to avoid the obstruction. The steering wheel was located at knee level to the seated operator which required steering control to be accomplished by grasping the steering wheel on the top portion. The operator's right hand was on the gear shift at the time of impact. Due to the location of the steering wheel, it is reasonable to assume that a collision avoidance maneuver requiring a turn of over 15-20 degrees could not be accomplished with one hand.

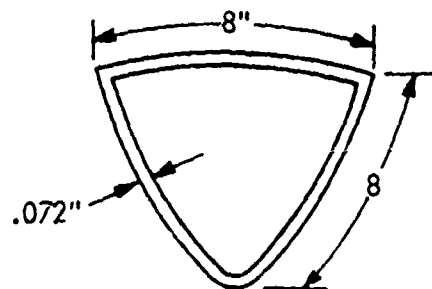
In order to collapse the bow sufficient force must be applied to cause permanent yielding of the aluminum over an area of a curved triangle some 8 in. on a side. See sketch below.

The area of metal involved would be approximately  $3 \times 8 \times 0.072 = 1.728 \text{ in}^2$

The depth of collapse is estimated as at least 8 in.

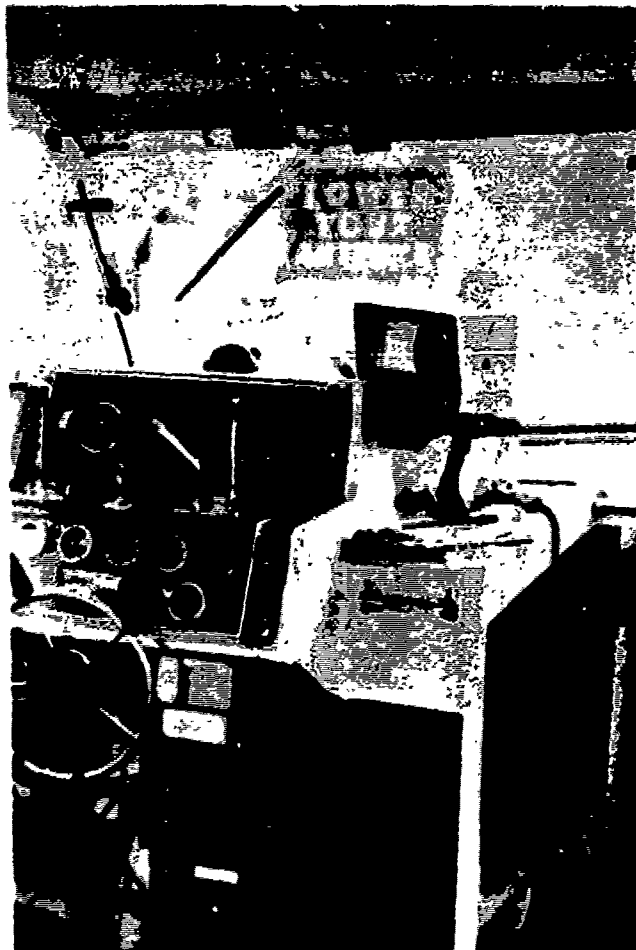
**Figure 5. (Top) - Control Console  
(Bottom) - Visibility From Helm (Note Windshield in Up Position)**

The operator never saw the inner and outer red lights that were closer to him than the green light that he did see. At some point in his approach to Ludington, these red lights had to have been in his visual field, although by the time of the accident, they may have been in his peripheral field. The fact that other boaters had complained about the two red lights suggests that they are not bright enough to be seen under some circumstances. The USCG personnel stated that other boaters who used Ludington Harbor had complained about the lack of visibility of the red lights. The operator's boat had its 360° white light mounted on the windshield about three feet from the operator. The windshield is narrow and the bow rails are in the line of sight and would reflect glare from the 360° white light (see Figures 4 and 5).

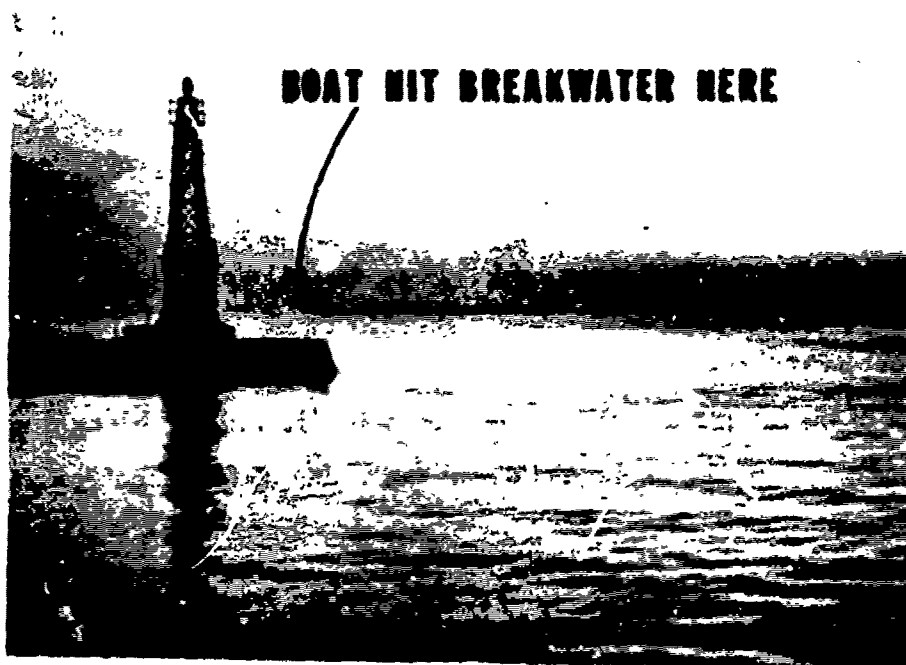
Figure 6. (Top) - Breakwater at Dusk  
(Bottom) - Breakwater - Inner Red Light In Foreground

Suggestions have been made concerning the use of high intensity quick flashing lights similar to those used to mark airport runways and aircraft at night. If the first two lighted aids at each inlet were of this type, they may provide a more visible target to shoot for. This accident might have been avoided as well as at least half a dozen similar ones that were reported this year if the operator had been sure of his position relative to the entrance of the inlet.

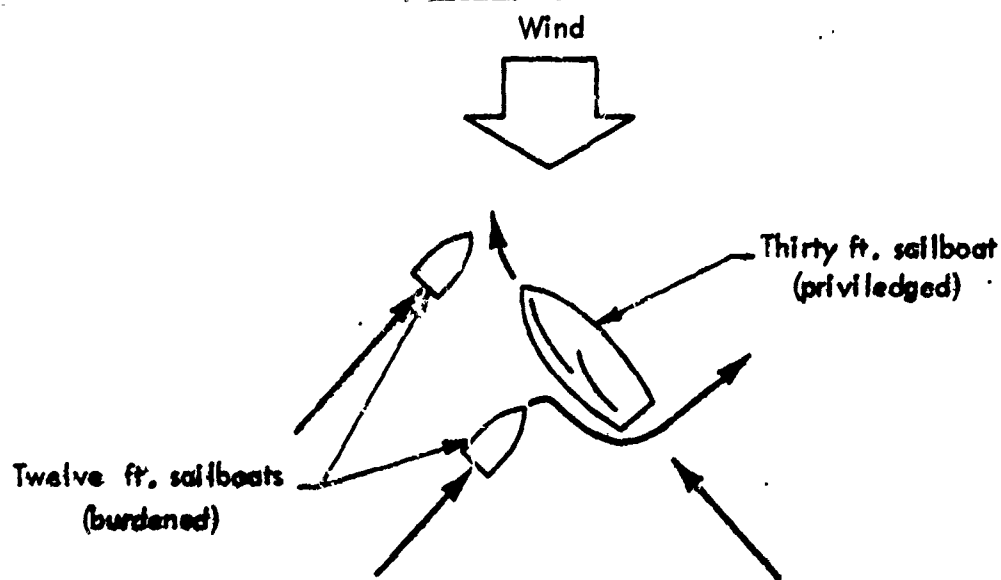
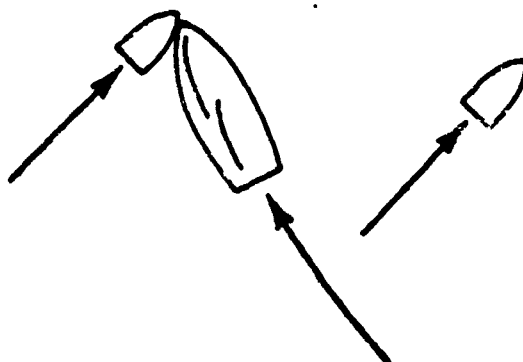
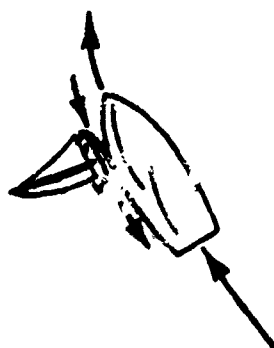
Figure 2. Accident Scenario

First twelve ft sailboat passed "under" the thirty ft boat.

Thirty ft boat "headed up" and hit second twelve ft boat.

Twelve ft boat capsized and slid along port side of thirty ft boat.

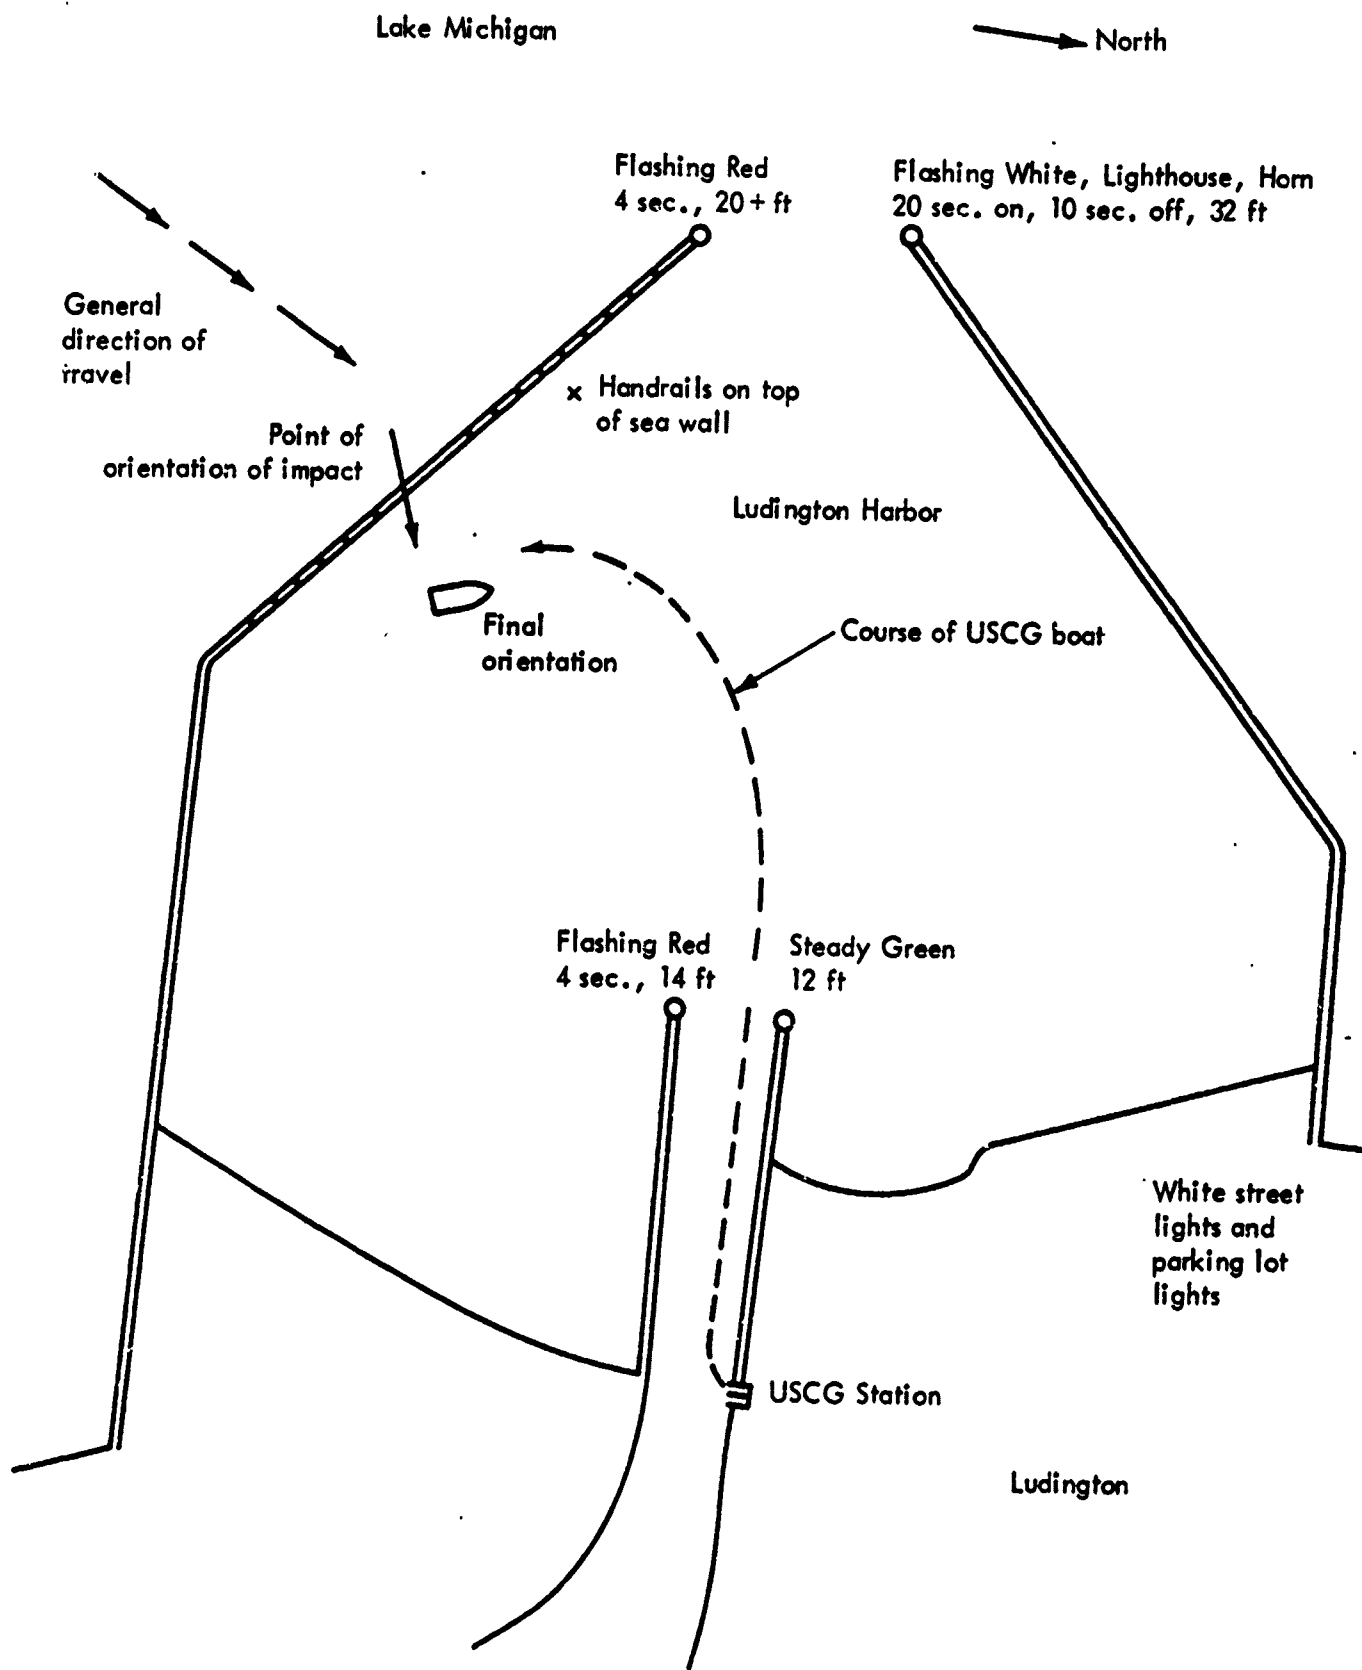
In the interview, the operator referred to the "beautiful weather." It was clear and calm. Sunset was 2129. Visibility was good. The air temperature was 68° F. There were no other boats in the vicinity at the time and the water depth was six feet at the point of impact with the sea wall. There were several harbor light, shore street lights, and parking lot lights on (see Figure 1) that were visible from the vicinity of the breakwater.

Figure 1. Diagram of Accident Site

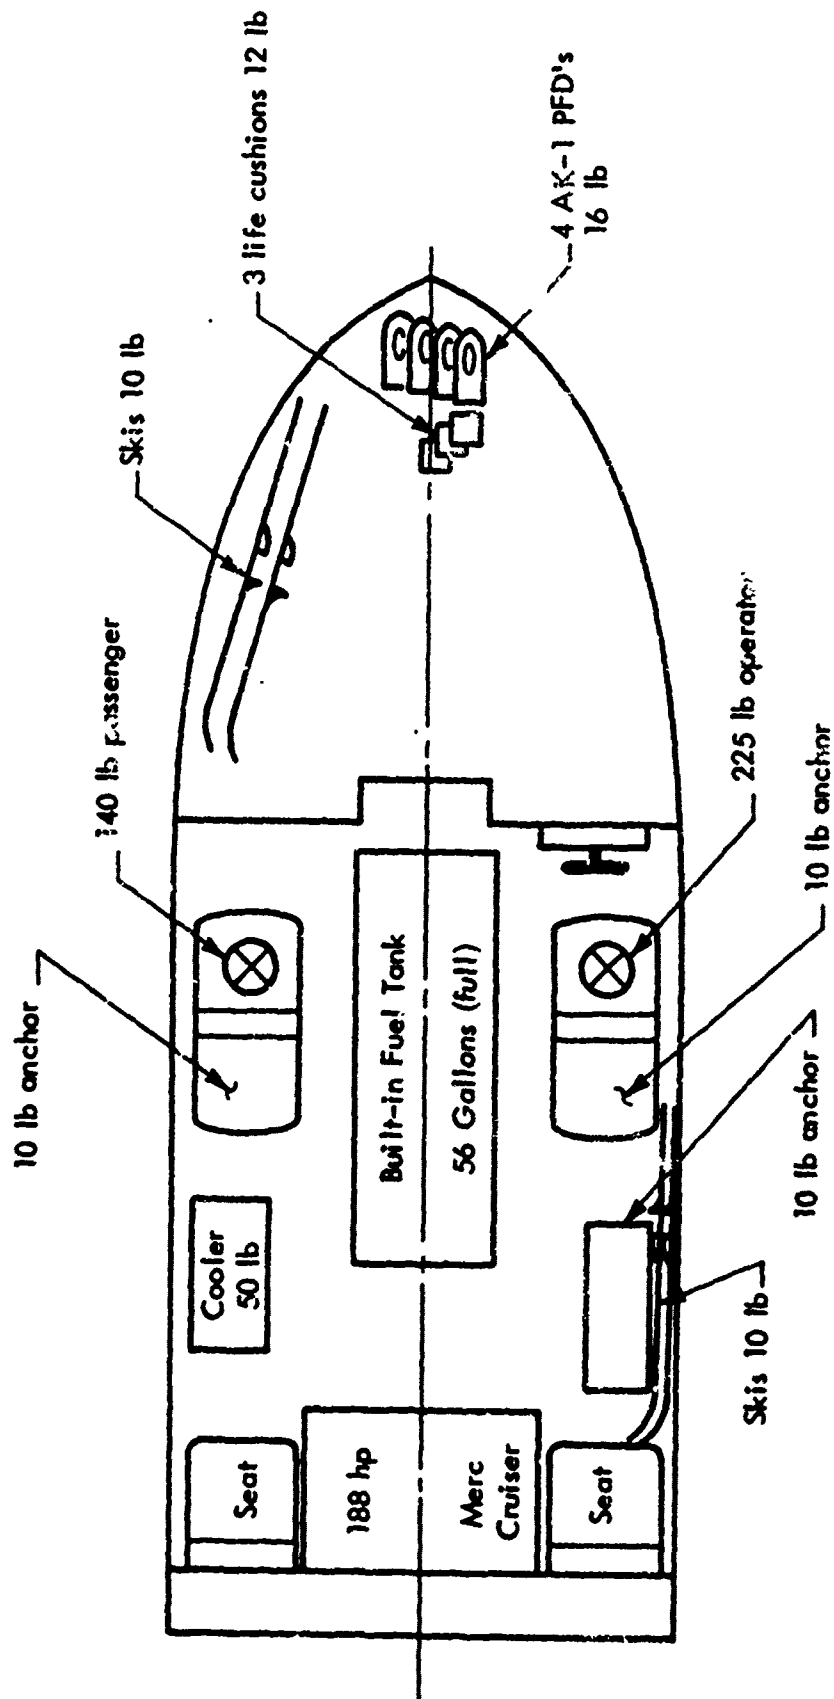
The locations of occupants and gear are shown in Figure 6. There were plenty of PFD's, although none were being worn. Soon after impact, the operator got a couple of these out of the bow in case they were needed. The lights were operable and on: separated red and green mounted on the cockpit sides and combined fore and aft white lights (360° total coverage) on a pole above the windshield. A control switch enabled the operator to have all lights on, or just the windshield white lights, or none. The boat was equipped with a compass which the operator thought was fairly accurate.

Figure 6. Locations of Occupants and Gear

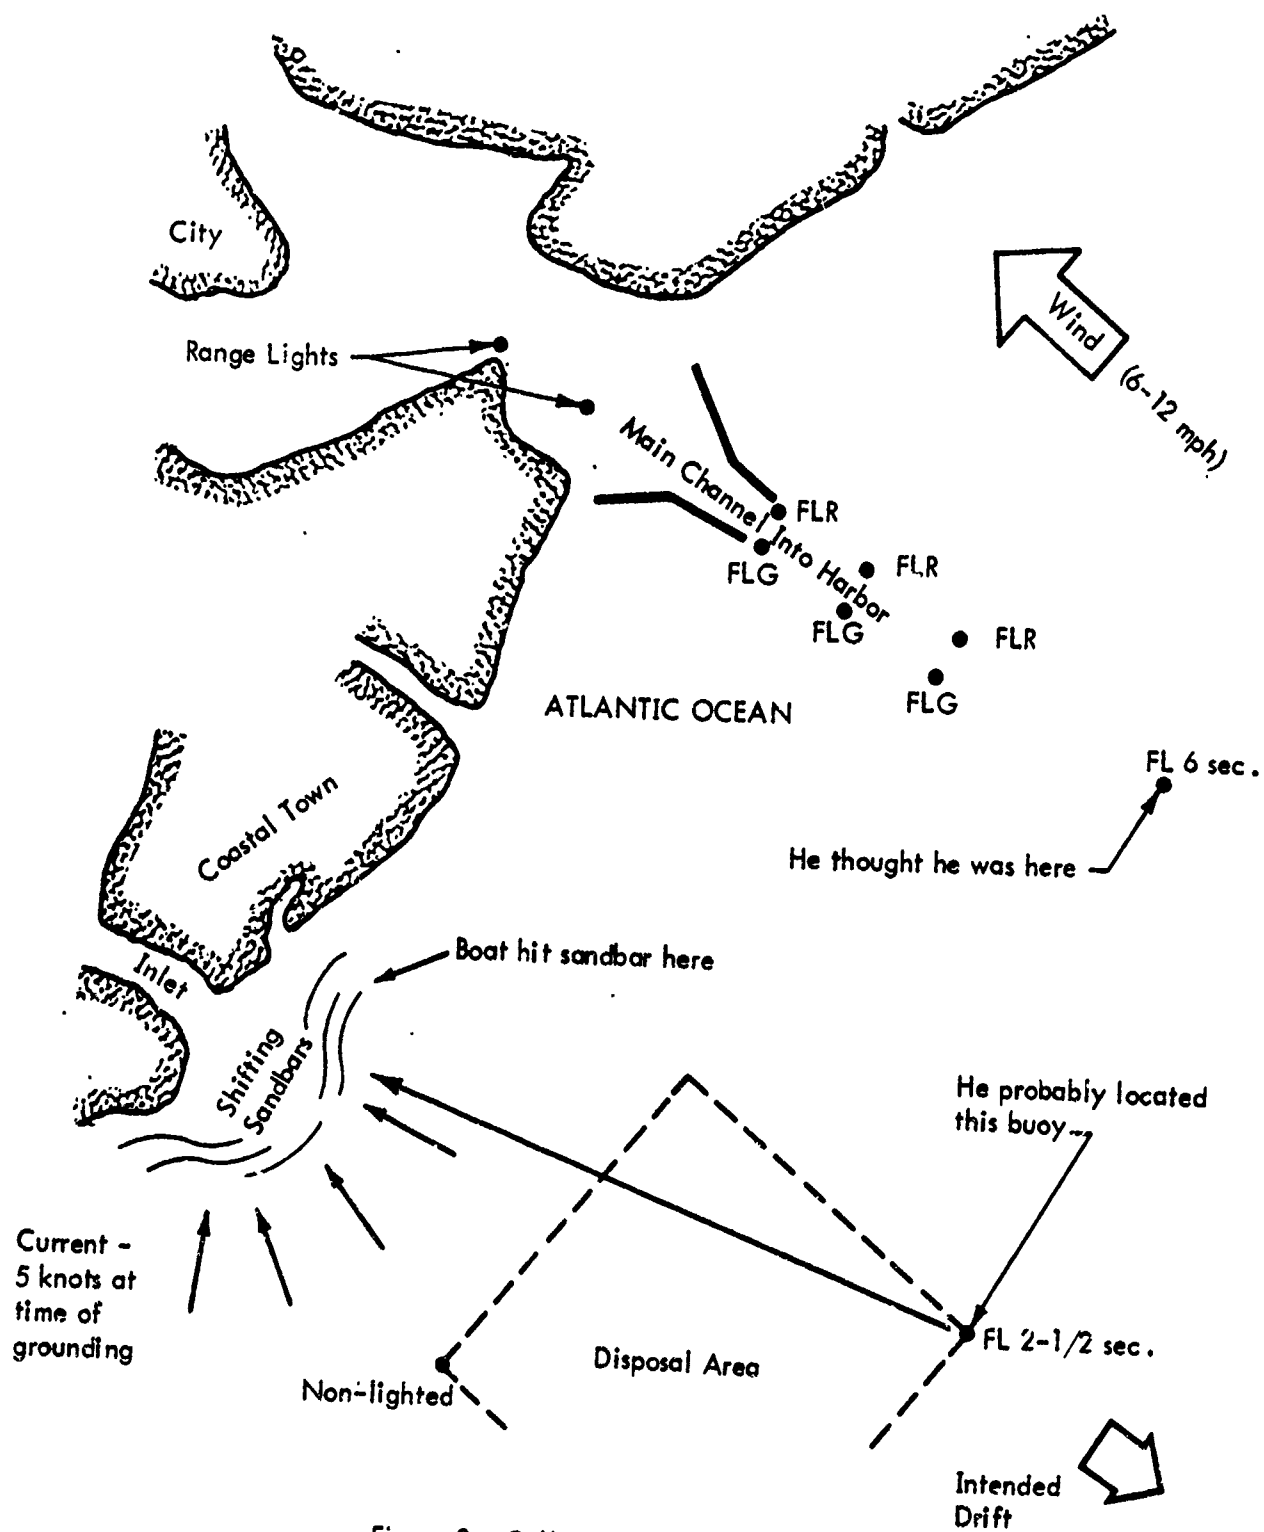
Figure 2. Collision Area Diagram

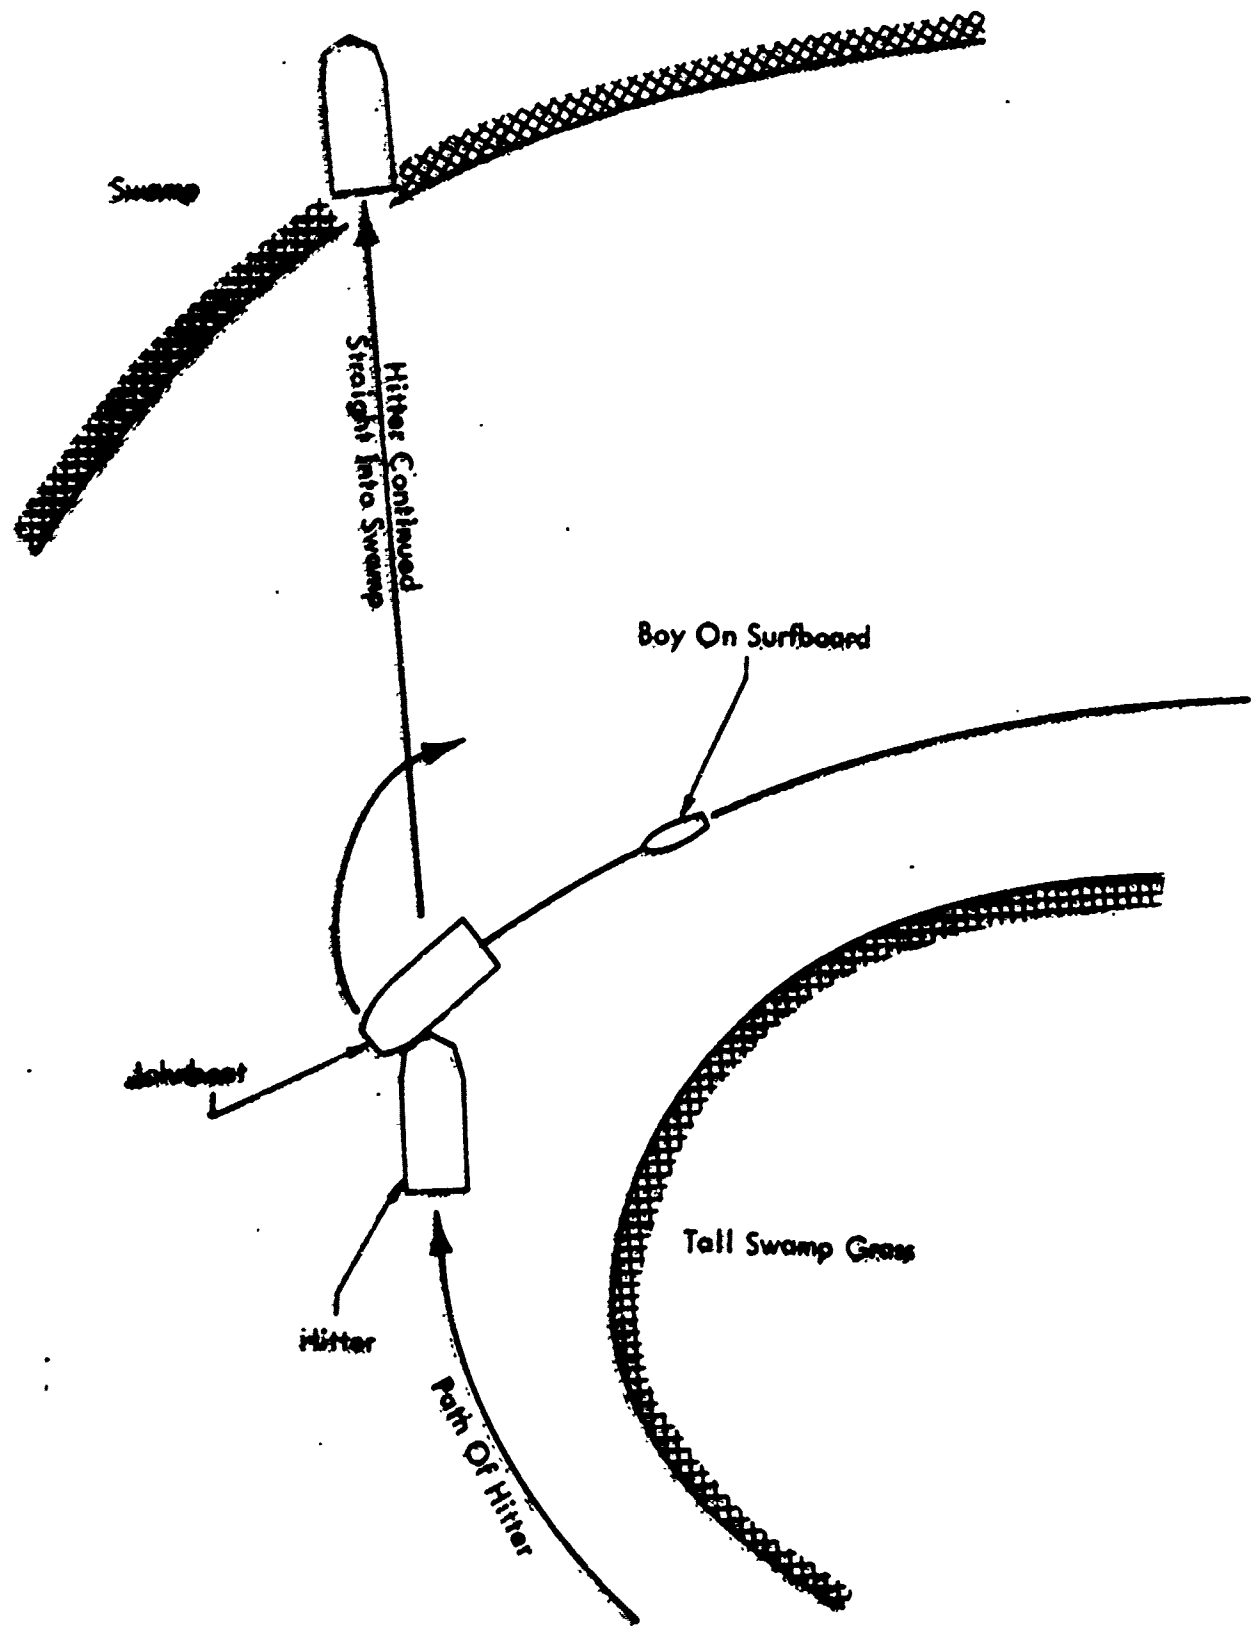
Figure 1. Accident Area Diagram

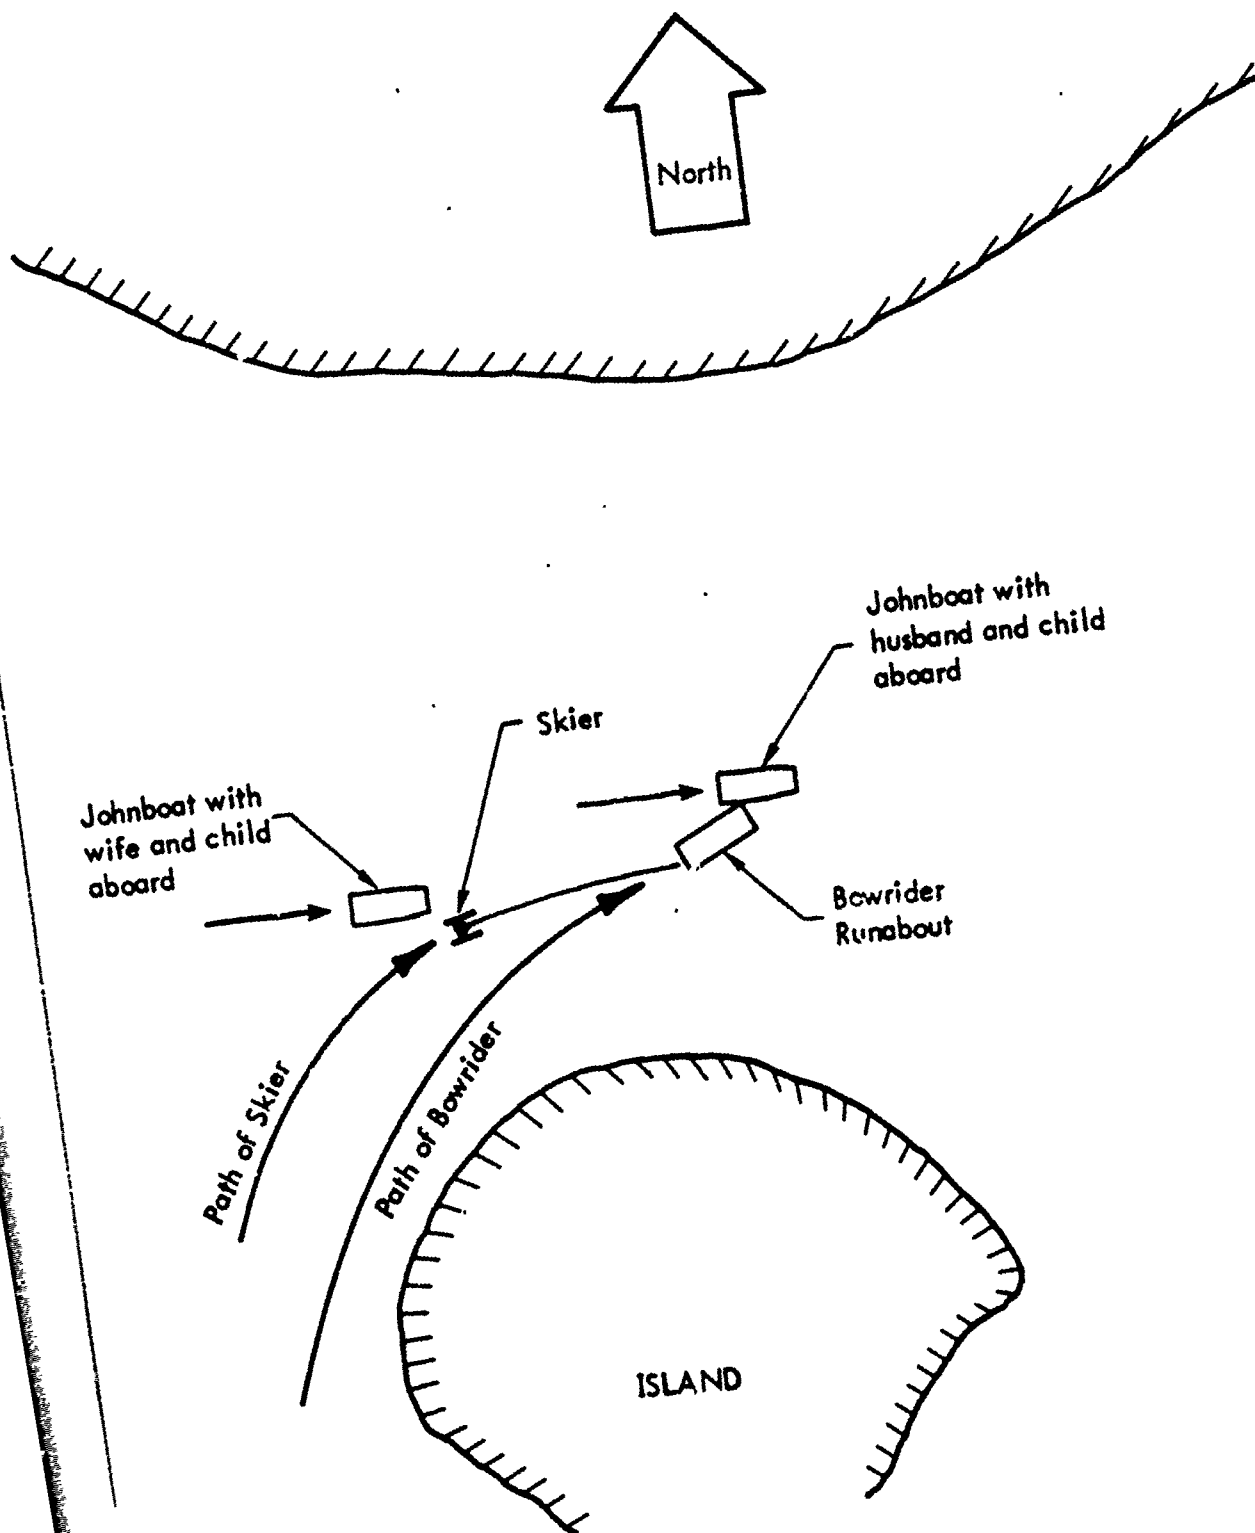
Figure 1. Collision Area Diagram
